BINDER LAKE DAM

COLE COUNTY, MISSOURI

MO. 30051

PHASE 1 INSPECTION REPORT
NATIONAL DAM SAFETY PROGRAM

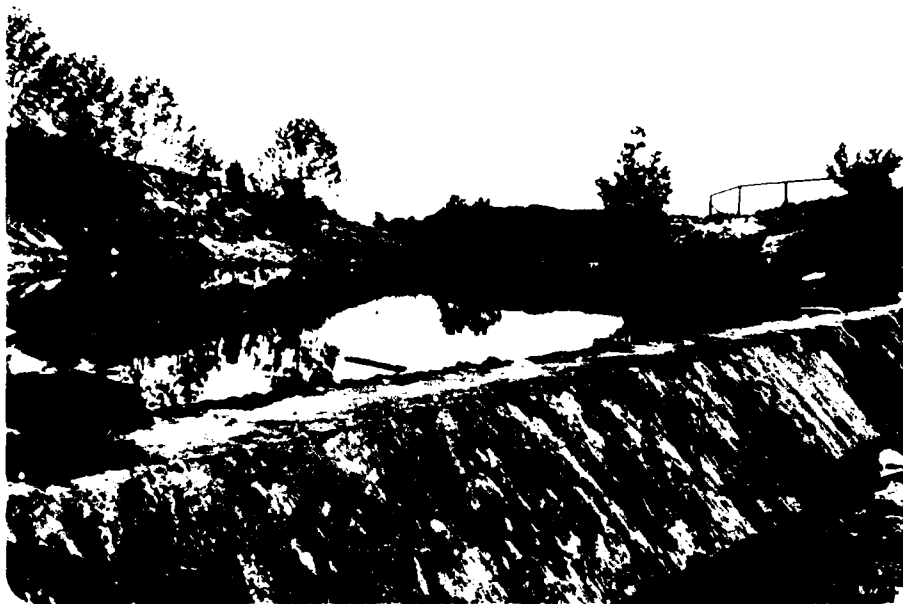
- (1) Principal spillway. Some erosion, spalling, and weathering of the limestone, with resulting undercutting, was observed at and under the downstream toe of the concrete weir control structure. (See photos 10, 11 and 13.) There is seepage outcropping along the downstream edge of the weir, predominately on both ends. All seepage is clear and the total effluent was estimated at $0.5 \pm$ gal./min. The exit channel is eroded bedrock with several small trees and shrubs growing in the cracks and erosion channels. The reservoir level was slightly below the crest of the weir.

PHOTO NO. 10 - UPSTREAM FROM RIGHT END SHOWING CONCRETE SILL
IN PRINCIPAL SPILLWAY

- (1) The present maintenance program is generally adequate.
- (2) Erosion and deterioration of the bedrock foundation under the principal spillway weir should be repaired and controlled.
- (3) The condition of the upstream riprap should be evaluated regularly and rehabilitation measures provided, as needed.

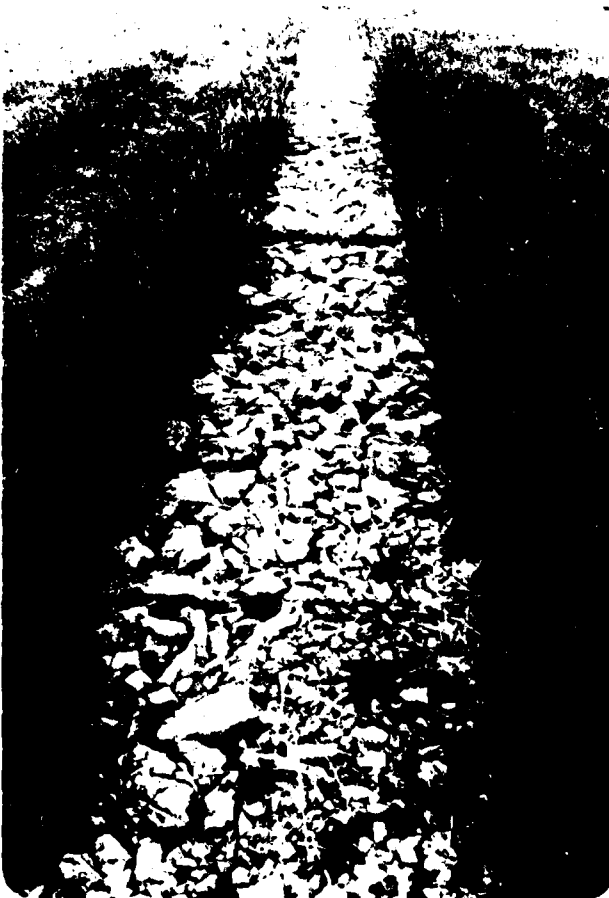
- (2) The emergency spillway. The emergency spillway is well vegetated with adapted grasses and was recently mowed. It looks very good with no evidence of erosion or deterioration. The plans show the crest of the rock gabion structure as 1 foot above the spillway grade line. At the time of inspection the top of the gabion sill was essentially at the same elevation as the bottom of the spillway. This may indicate that the spillway bottom was plated with about 1 foot of topsoil for vegetation purposes. The rock gabion structure looks good with very little deterioration but it has not been used or tested to date.

PHOTO NO. 15 -
GABION SILL IN
EMERGENCY SPILLWAY
